Community Environmental Response Facilitation Act (CERFA) Report

**Lexington-Bluegrass Army Depot
Fayette County, Kentucky**

April 1994

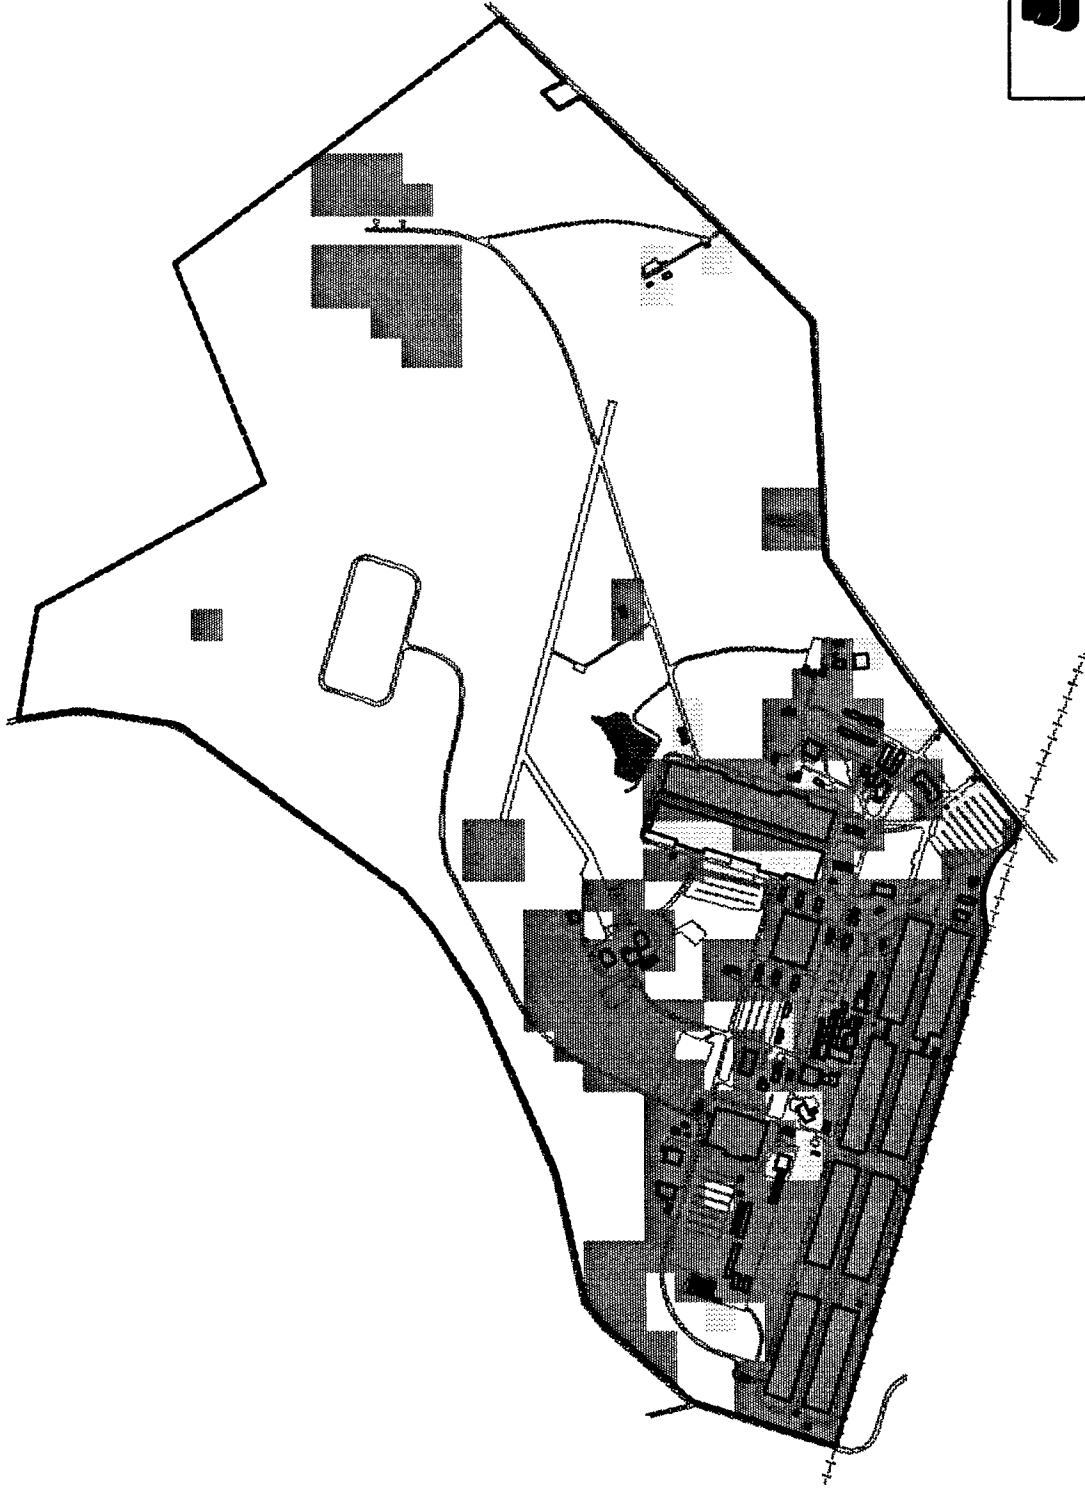
BRAC Property Boundary

- CERFA Parcel
- CERFA Parcel with Qualifiers
- CERFA Disqualified Parcel
- CERFA Excluded Parcel
